# Manhole Inspection Summary

Manhole # S27M\_\_048MH

Insp Date: **5/13/08 2:10 PM**

**Location** Address: **1127 Sargeant ST**

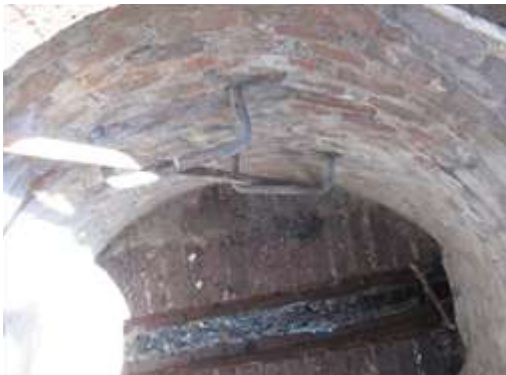
Misc

debris between rungs

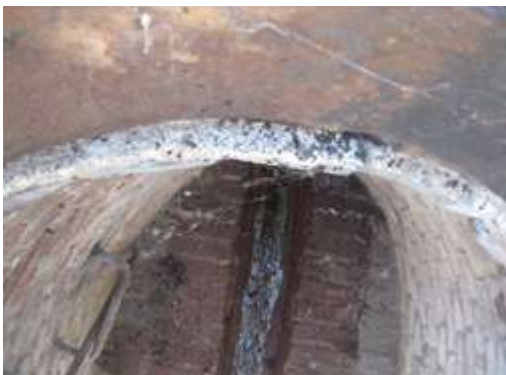
Defect 2

Offset: **0.** (in.)  
**25**

offset .25 inches

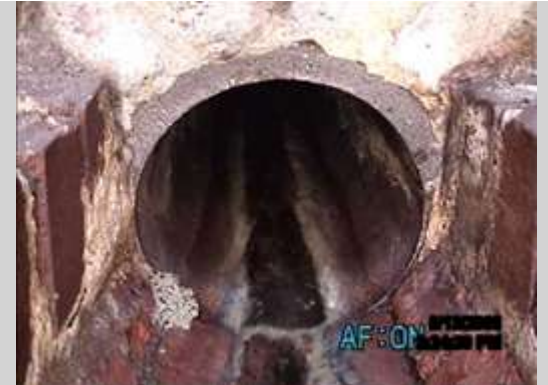
12 O'Clock Outflow

8 in. Circular Gravity Sewer  
Pipe Out @ 12 O'Clock

Pipe Height: **8.4** (in.) Rod and Bar (Angled)  
Pipe Material: **Clay** ☐ Pipe Lined  
Invert Depth: **6.03** (ft.) Flow Characteristics: **Fast**  
Deposits: ☒ None ☐ Mud ☐ Sludge ☐ Debris ☐ Grease  
Silt Depth: **0** (in.) Deposits Extent:  
Infiltration: **None** Pipe Seal Cond: **Sound**

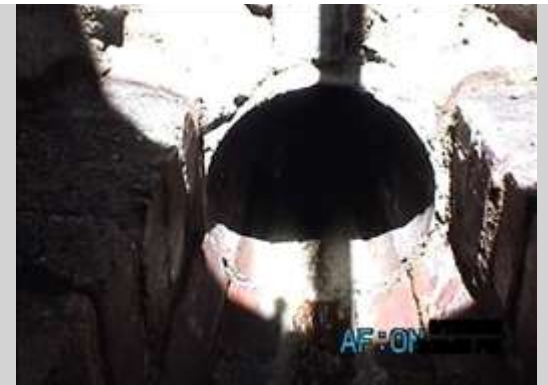
6 O'Clock Inflow

8 in. Circular Gravity Sewer  
Pipe In @ 6 O'Clock

Pipe Height: **8.4** (in.) Rod and Bar (Angled)  
Pipe Material: **Clay** ☐ Pipe Lined  
Invert Depth: **5.87** (ft.) Flow Characteristics: **Fast**  
Deposits: ☒ None ☐ Mud ☐ Sludge ☐ Debris ☐ Grease  
Silt Depth: **0** (in.) Deposits Extent:  
Infiltration: **None** Pipe Seal Cond: **Sound**
